## **TEST REPORT**

**Report No**.: G8784.01-109-44

## **PRODUCT TYPE**: Curb Mounted Skylight **SERIES/MODEL**: Specials 0.118 Polycarbonate Single Dome Skylight

**SPECIFICATION**: Occupational Safety and Health Administration/U.S. Department of Labor Regulations (Standards- 29 CFR)- 1910.23(e)(8).

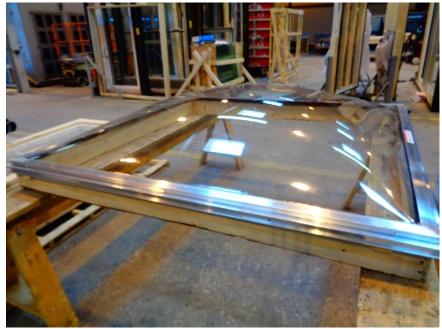
Photo No. 1 View of Tested Specimen

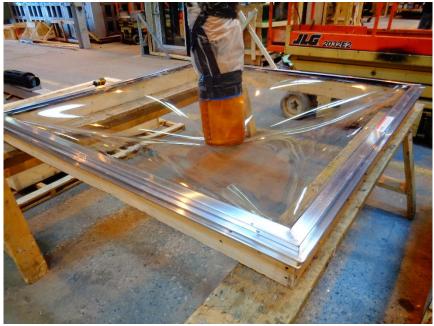
Photo No. 2 View of Tested Specimen with 400 lbs Applied

A 400 lbf weight, fabricated from a bag filled with lead shot, was placed on the center of the dome for a minimum of 60 seconds. The bag was removed and the test unit was inspected for any signs of damage or failure.

Test Load	Load Location	Results
400 lbf	Center of dome	No visible damage

*Note*: The 400 lbf weight was gently applied perpendicular to the center of each dome. After 60 seconds of rest time, there was no visible damage to either skylight.
